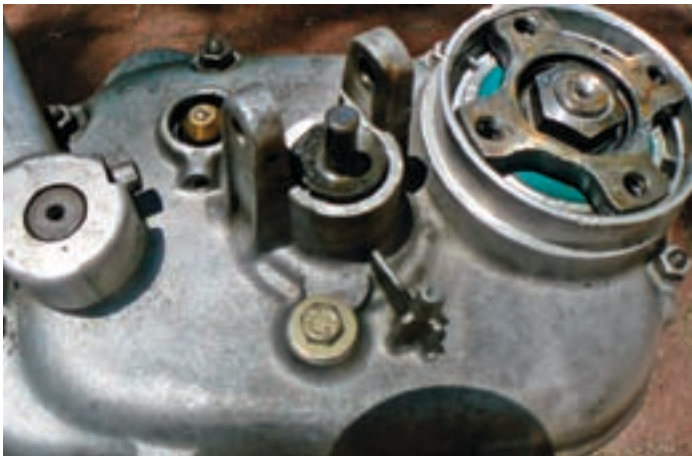
The idler gear has been replaced, with the shaft being given some "extra" hold-in-place security. In addition to the added small bolt and washer, the shaft was peened and secured with high-strength Loctite.

The gears and bearings in this gearbox were in fine shape and needed no attention other than a good cleaning of the old oil in the case. While things cooled down, the old gasket material was scraped off. The shaft that the idler gear turns on was mounted in a drill press vise and drilled and then tapped for a 6mm short bolt. This will be used to secure a washer that will keep the shaft in place when it is replaced in the cover. The shaft was also peened with a punch to increase the tightness of the fit. As a final measure, permanent Loctite was applied when the shaft was replaced in the cover.

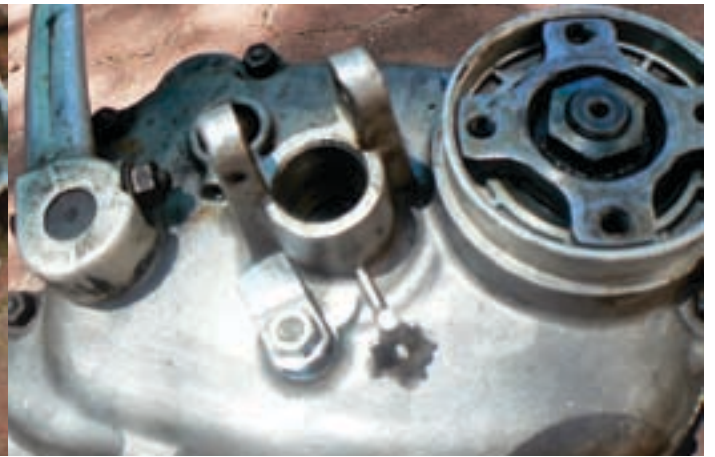
This similar repair to the idler gear shaft was done to a spare 4-speed I purchased a couple of years ago. While looking a bit rougher, I'm sure it did the job of securing the shaft.
